Vegetation and Rare Plant Survey Report

DWR Tehachapi East Afterbay Project

Prepared by:

Xeric Specialties Consulting

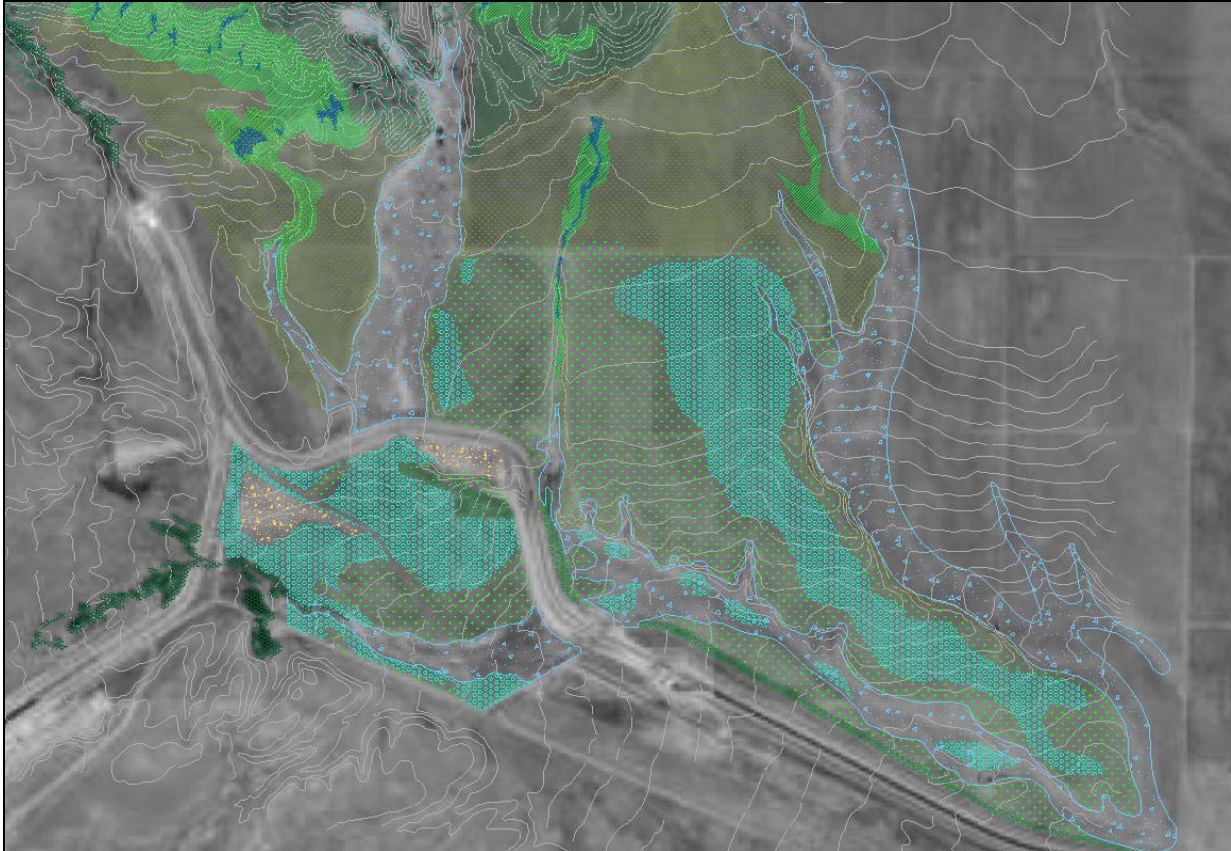
Figure 2. Vegetation map overlaid on a 1994 USGS Terra Server aerial image of the proposed afterbay enlargement site.

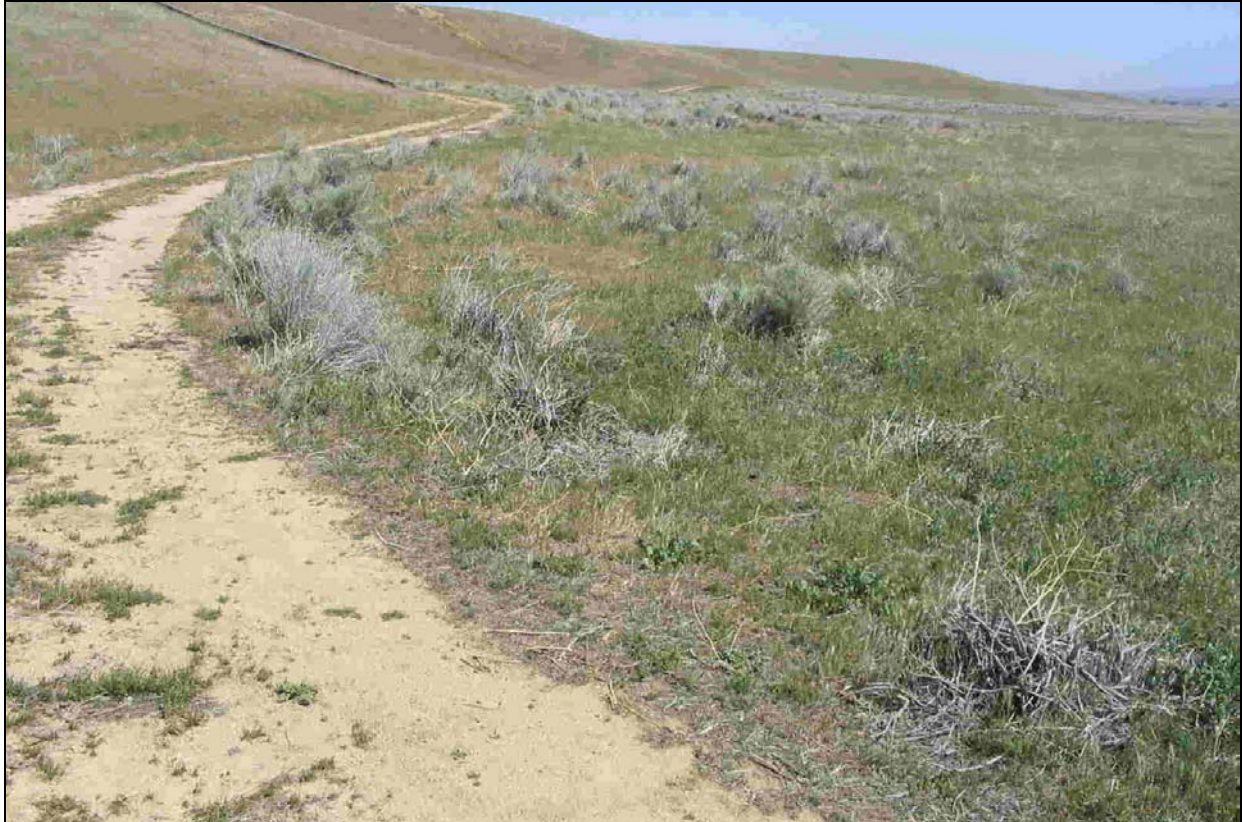
Photo 3. View of south end of proposed spoil pile (Spoil #1) where flats slope off into the more-sandy channel bottom soils of an alluvial floodpath. Drainages with erosion cuts occur between the toes of the slopes.

The southern end of the site, near the south edge of the proposed spoil pile (Spoil #1), slopes into a broad alluvial floodpath where soils are sandier than up on the terraced flats. The broad alluvial floodpath is a very low angle drainage path without channels or obvious watercourses. It is defined by the sandy soils and alluvial fill, more than the vegetation or geomorphology. The south edge of the terrace is marked by a smooth slope (Photo 3) with erosion cut drainages at various intervals (Photo 4).

“Wash Succession” is mapped for the broad sandy channels (Photo 11), erosion cut drainages (Photo 4) and alluvial floodpaths (Photo 3). This vegetation type is defined by sandy soils and intermittent surface/subsurface flow hydrology, rather than by a homogenous vegetation cover. The vegetation is ambiguous for much of these areas, in part due to the current disturbed state. The meandering flow paths, variable surface flows, oscillating water tables and active fill of the drainages are additional local

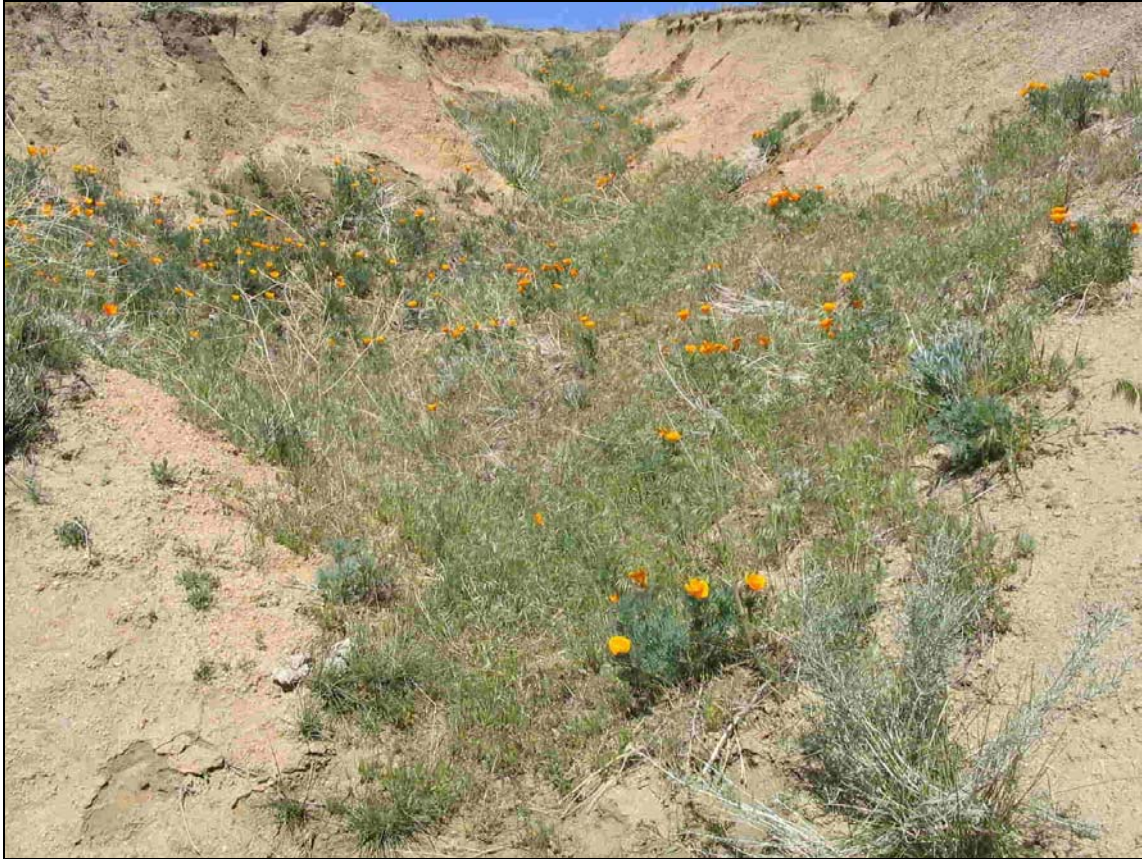
Photo 4. Erosion cut drainage at southwest end of proposed spoil pile (Spoil #1) with California poppies (*Eschscholzia californica*), otherwise mostly weedy plants, rabbitbrush and sand-aster (*Lessingia filaginifolia*). Though often identified with native California, the presence of poppies is not a good indicator of habitat quality because of their affinity for disturbed sites.

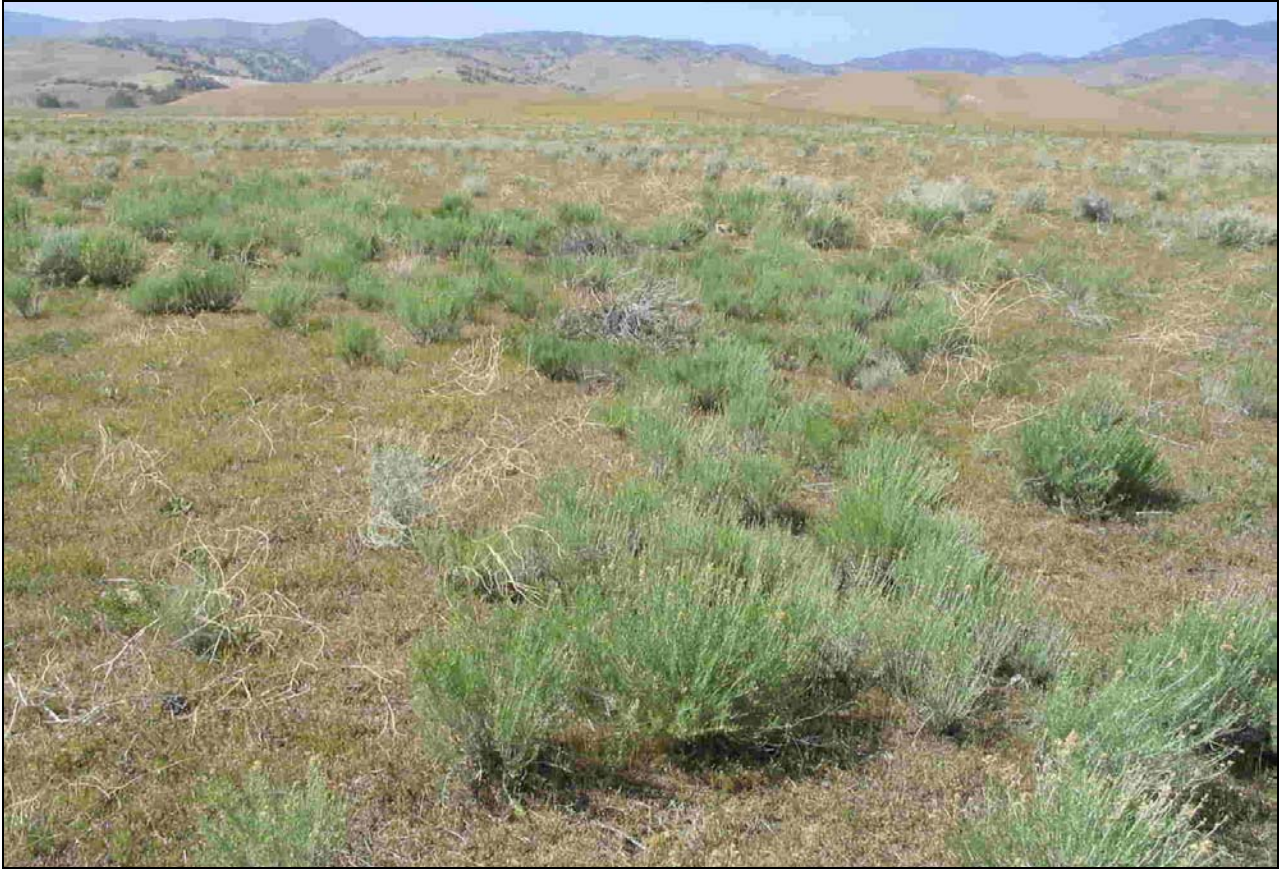
Photo 7. In the northern part of the site, where the proposed reservoir would be located, the greener *mohavensis* variety of rabbitbrush (*Chrysothamnus nauseosus* var. *mohavensis*) was present in patches. The lighter colored *hololeucas* variety, which is the more native and prominent form in this region, can be seen in the background and in the next photo. This portion of the site seemed to have the best vegetation condition relative to the other areas on-site, but still very when compared to intact sites in the region that have not been so disturbed by grazing and plowing.

“Rabbitbrush Succession” is mapped for areas where rubber rabbitbrush (*Chrysothamnus nauseosus* var. *hololeucas* and var. *mohavensis*) occur in prominent stands (Photos 7 and 8) among weedy herb covers that are, on average, still the dominant cover despite the shrub frequency. This association is more or less the same as the herbaceous succession type, except that rabbitbrush is more frequent. A few other shrubs are rare in this vegetation type. Native annual plants are scattered (Photo 9) in this type, but a little more frequent than in the open Herbaceous Succession type, perhaps an indicator (along with the rabbitbrush) of more stability and succession.

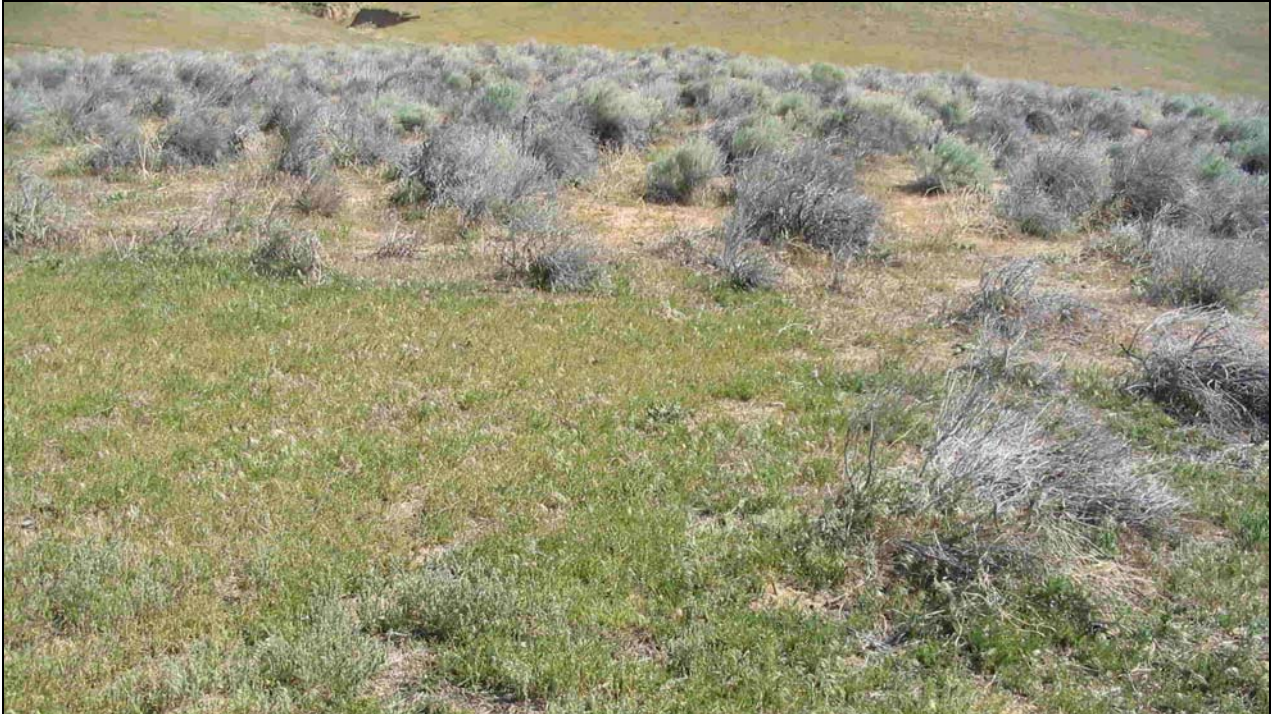
Photo 8. The *hololeucas* variety of rabbitbrush (*Chrysothamnus nauseosus* var. *hololeucas*), this patch is concentrated on sandy soils at the mouth of an erosion cut drainage.

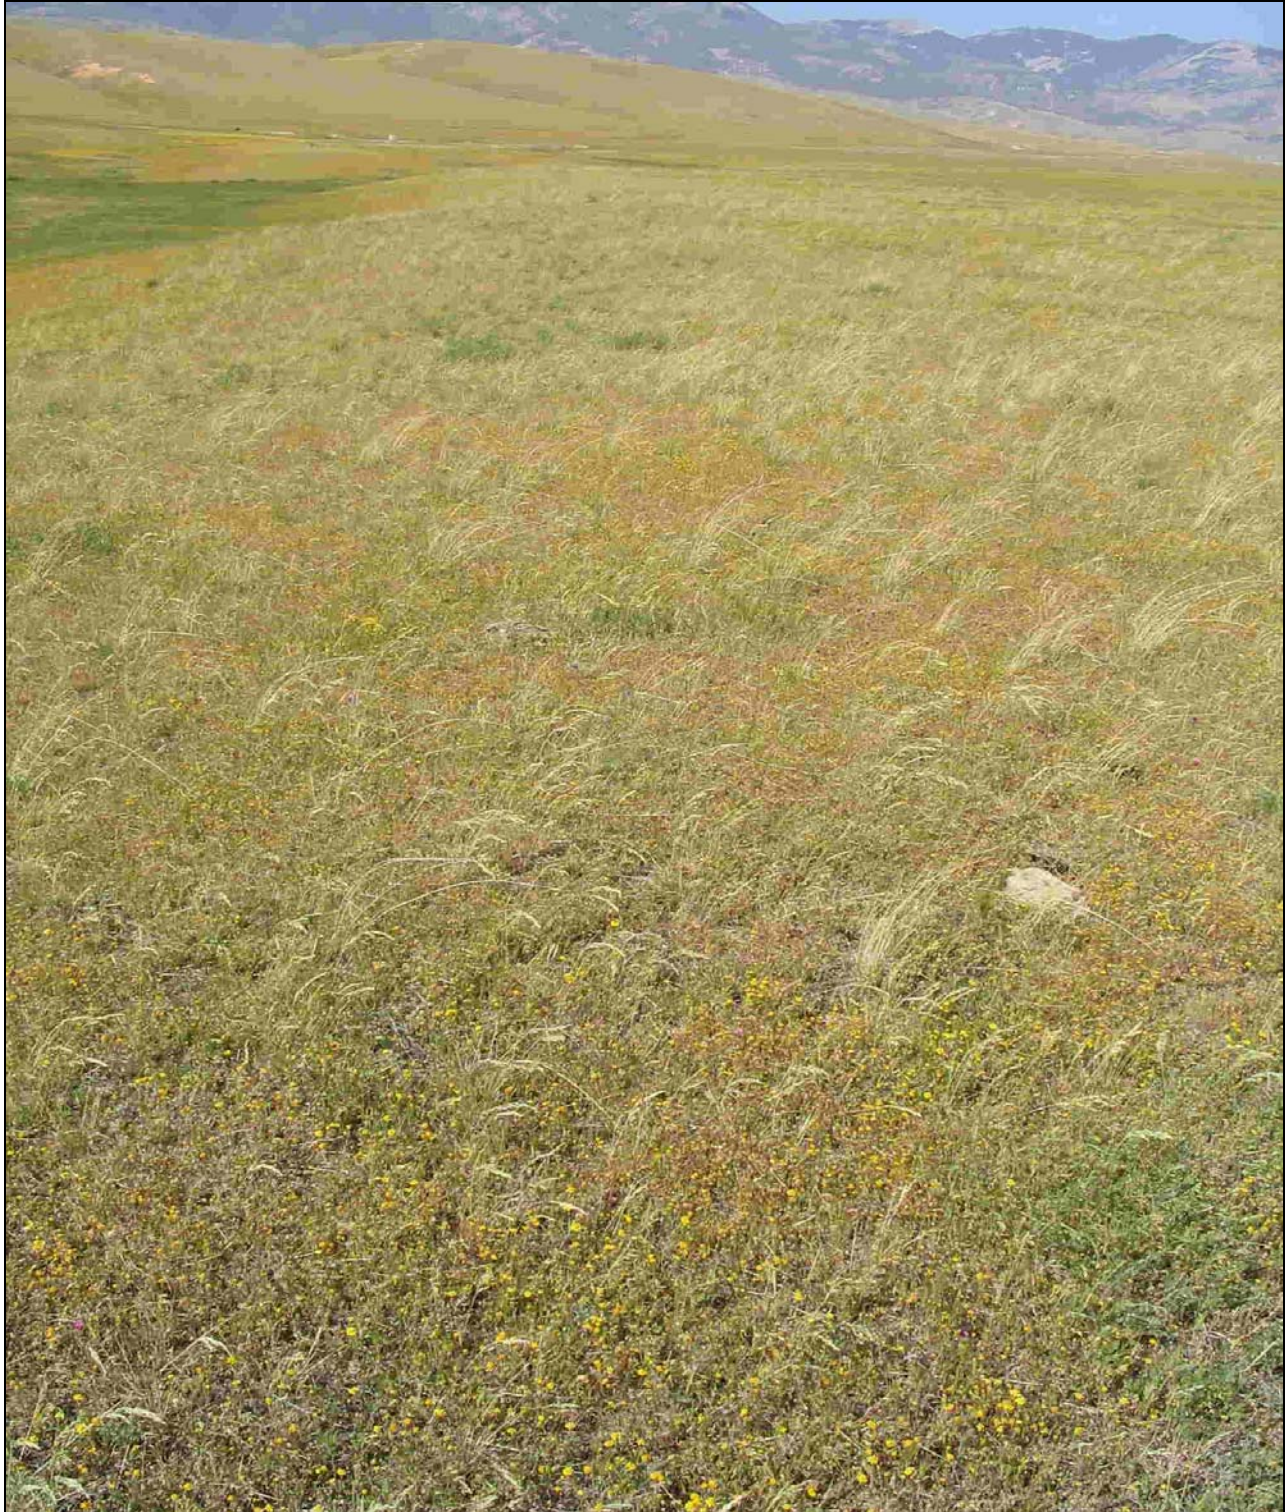
Photo 10. Example of Terrace Grassland vegetation type north of the proposed reservoir site, beyond the 28/33 section line fence and into the low foothills. Nodding needlegrass (*Nasella cernua*) and bluegrass (*Poa secunda*) were common with goldfields. The densities were high enough in this area to be classed as a native grassland vegetation type. This grass was much reduced in the proposed alternative site, mostly restricted to the edge of drainages.

This vegetation association weakly occurs in the project footprint, but is dominant on the sloping terraces and foothills to the north (Photo 10) of the 28/33 section line fence and probably was the primary type of vegetation in the project area prior to the plowing of the soil and other human-induced disturbances. Strips of this vegetation type that have not been plowed persist along the edges of the disturbed terrace landforms, mostly associated with the unnamed drainage between the existing afterbay and proposed reservoir site, the southwest edge of the project terrace landform and along the banks of Big and Little Sycamore Canyon washes. The population of Sylvan microseris detected during the surveys is associated with one of these "strips." Nodding needlegrass (*Nasella cernua*), bluegrass (*Poa secunda*) and goldfields (*Lasthenia californica*) were the most conspicuous plants of this association, along with other exotic and native annual grasses and forbs. Rabbitbrush is nearly absent in this association; another indicator of lower disturbance levels.

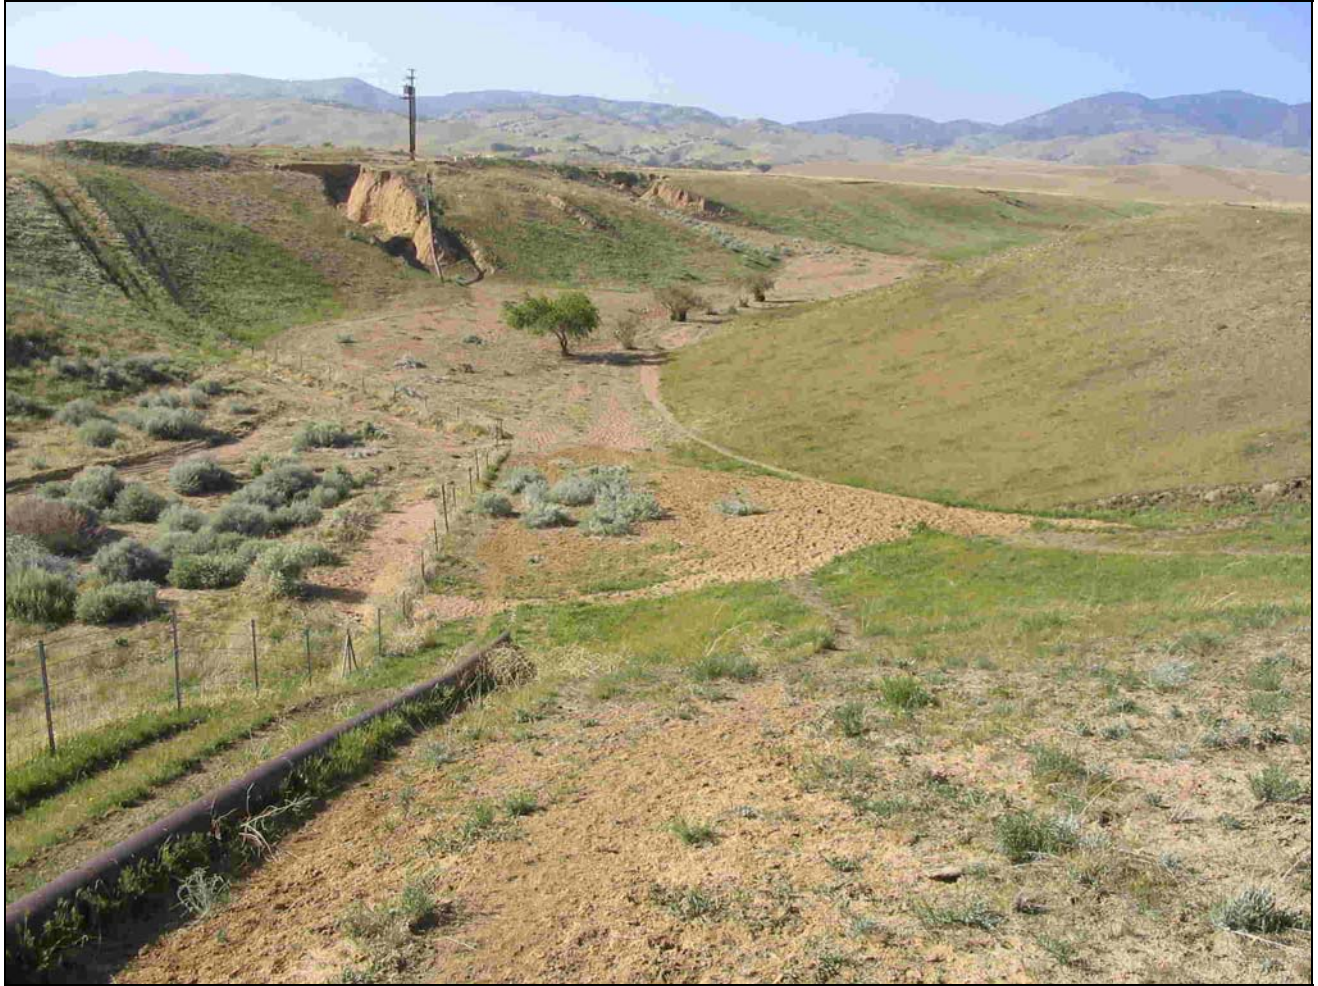
Photo 11. Dry drainage east of the northeast bifurcation of the aqueduct. A few riparian trees (red willow, tamarisk and mulefat) are “hanging on”, the soil beneath them “hammered” by cattle into dust. To the left, a cattle fence protects a portion of the drainage where scrubs and small trees still remain; probably the vegetation most similar to what might exist without the disturbance regime. The erosion cuts in the upper left are typical of all the drainages of the flats, but these are the deepest in the project area. The proposed outlet channel is just north of the erosion scars. The drainage is probably drier than pre-ranching conditions due to an earthen dam (see following pictures) further up the drainage, beyond the proposed outlet channel. The drainage slopes in the foreground were probably the most interesting area surveyed in terms of native plants, though still very disturbed. Sylvan Microseris (*Microseris sylvatica*, CNPS List 4) was collected from this slope (Photo 12).

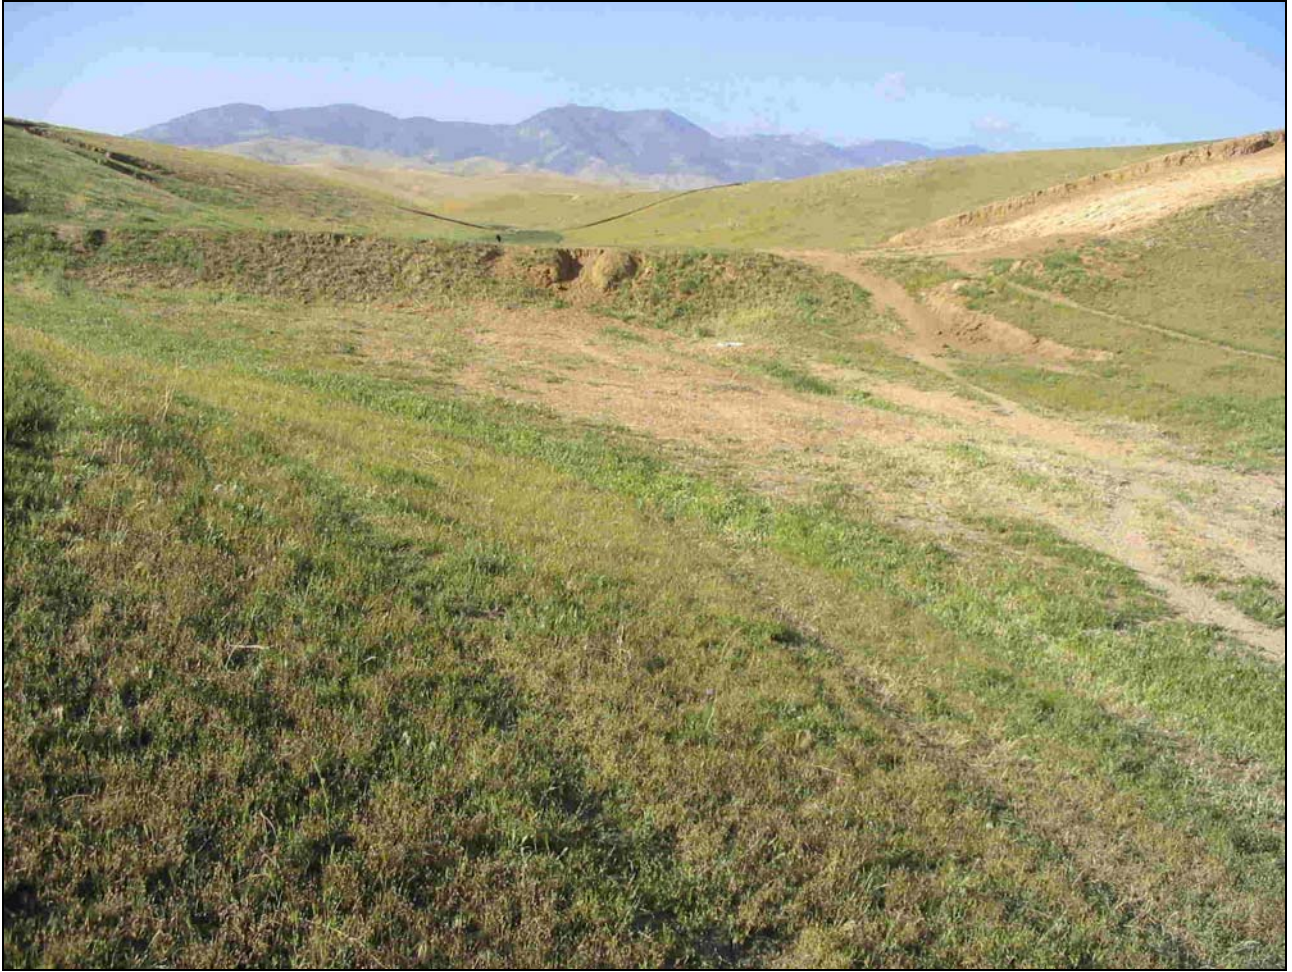
Photo 14. The earthen dam further up the drainage, north of the proposed outlet channel. This structure retains the surface flows effectively, more or less eliminating the presence of all herbaceous riparian plants below this point.

A natural drainage with a tapped spring and earthen dam flows southward from low foothills to the north of the site (Photos 14 and 15), between the existing afterbay and the proposed northeast alternative reservoir, such that connecting infrastructure will necessarily cross the drainage. The vegetation and faunal resources associated with the drainage are greatly reduced where the drainage enters the project footprint because an earthen dam traps surface water to the north of the project. Cattle activity is intensive in the drainage, and the soils have been altered into a nearly abiotic condition in comparison to intact soil-biota relationships of drainages in the region with similar topography and hydrology.

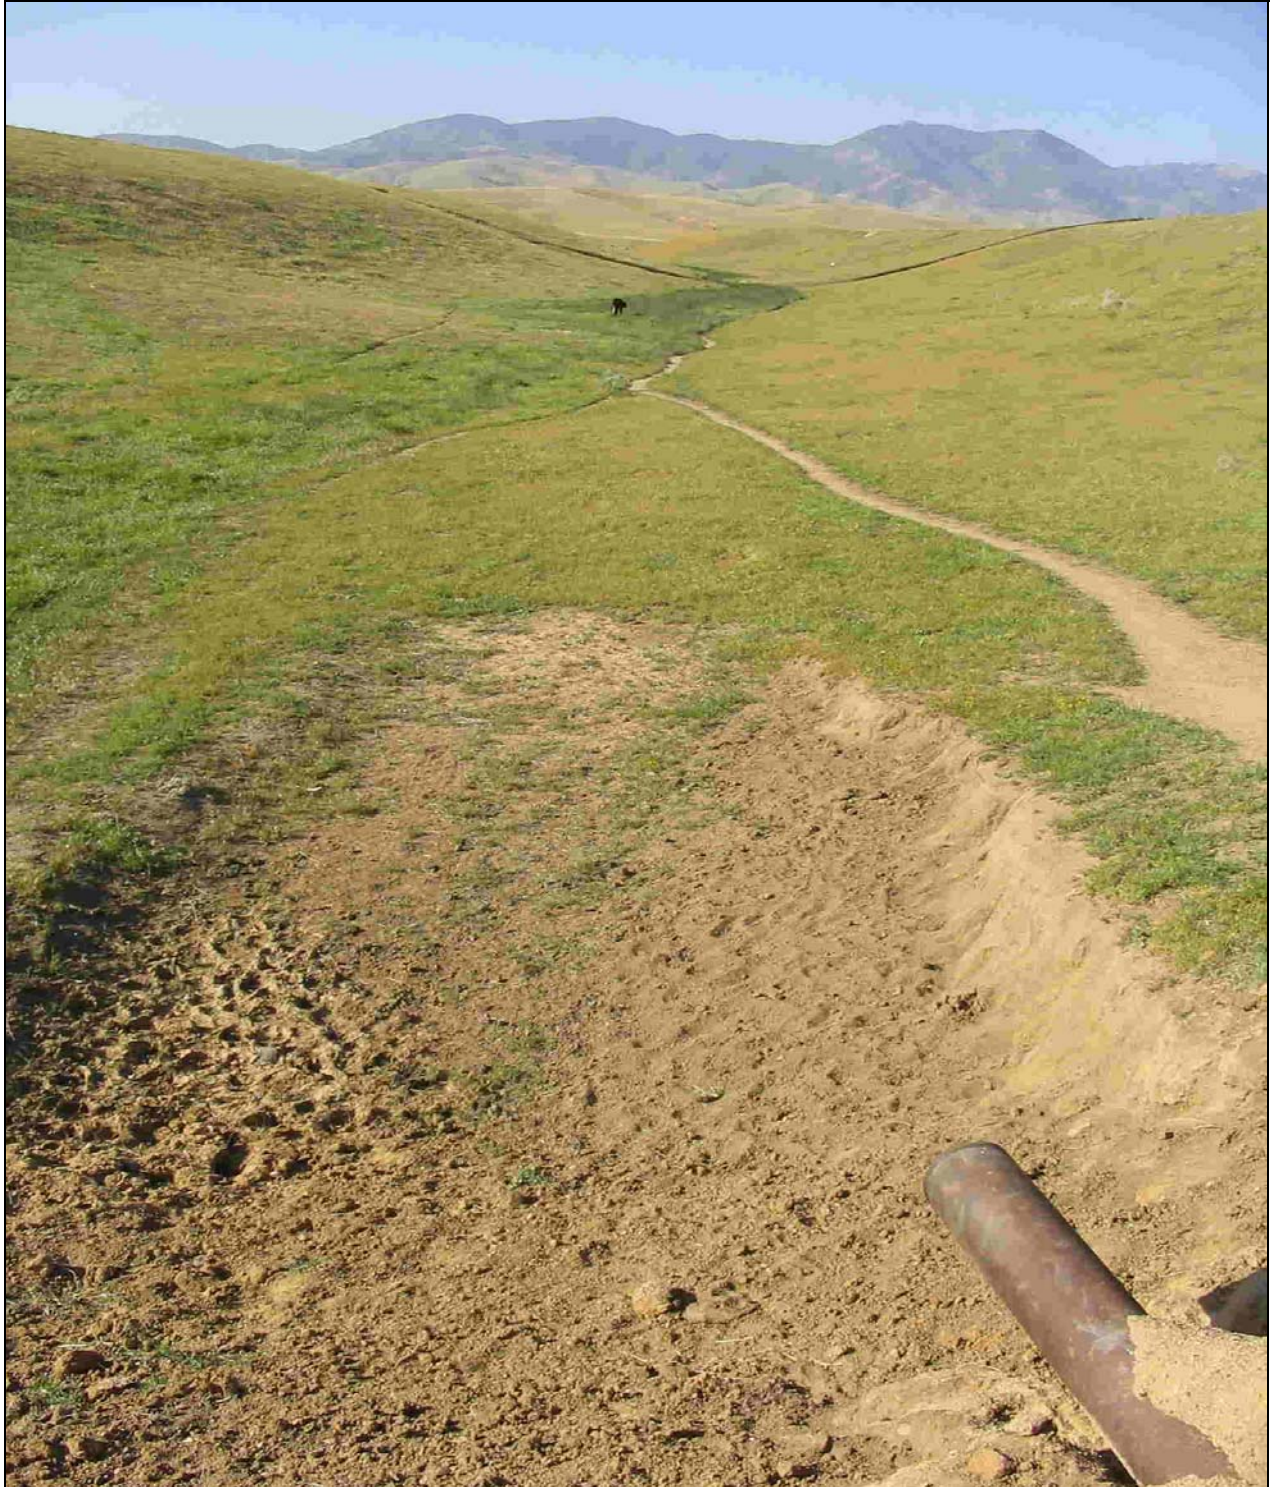
Photo 15. The riparian drainage contained to the north by the earthen dam. This area is beyond the proposed project footprint and does not seem to have any systemic impacts that would occur from the project alternative as proposed. The surface water that feeds this near-seasonal stream is feed by a tapped pipe in the foothill drainages to the north. The overflow pipe at the bottom of the picture appears not to have bypassed water through the dam in a long time. A low diversity riparian plant community, primarily composed of wire rush (*Juncus balticus*), spike-rush (*Eleocharis* sp.), and water speedwell (*Veronica anagallis-americana*), runs for approximately 500 meters with the surface flow. Western toad larvae (*Bufo boreas*) were present in the stream.

The natural drainage that extends north-south between the proposed reservoir site and the existing aqueduct supports a low diversity riparian stand of vegetation (Photo 15) from a tapped spring and is contained to the north of the project footprint by an earthen dam (Photo 14). Water speedwell (*Veronica anagallis-americana*), wire rush (*Juncus balticus*), spike-rush (*Eleocharis*), and water-cress (*Rorippa*) are the dominant covers in this stand. A pond and associated drainage system to the north of the 28/33 section line has similar vegetation and feeds into the drainage associated with the project site. Other areas of this vegetation type are less disturbed and altered and generally have more species present.
